THE  
ECCLESIASTICAL  
ARCHITECTURE  
OF SCOTLAND

FROM THE EARLIEST CHRISTIAN TIMES TO THE  
SEVENTEENTH CENTURY

BY  
DAVID MACGIBBON AND THOMAS ROSS  
AUTHORS OF "THE CASTELLATED AND DOMESTIC ARCHITECTURE OF SCOTLAND"

VOLUME ONE

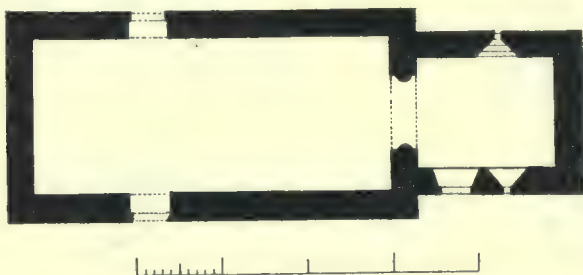
FIG. 186.—Birnie Church. Plan.

As it now stands, the edifice (Fig. 186) consists of nave and chancel, without aisles. The former measures 42 feet long by 18 feet 6 inches wide internally, and the latter is 16 feet long by 13 feet wide. The

nave has a doorway in the south wall, and another immediately opposite it in the north wall. The chancel has a small round-headed window in each of the north and south walls, and it is remarkable that there is no window in the east wall. There is also a doorway in the south wall of the chancel, which has evidently been added or enlarged at a comparatively late period. Every part of the building, both externally and internally, is perfectly plain. The only portion which presents the smallest approach to ornament is the chancel arch (Fig. 187). The opening is 7 feet 6 inches in width, and is flanked at each side by a substantial semi-circular attached shaft, which has a moulded base and a heavy Norman cap of the pattern founded on the cushion, with

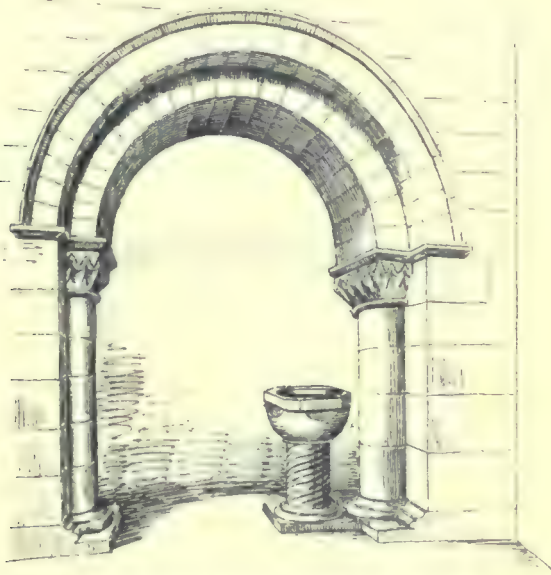
FIG. 187.—Birnie Church. Chancel Arch and Font.

numerous subdivisions. The upper part of the cap has also a small stepped ornament, similar to what exists at Jedburgh and elsewhere. The square abacus of the caps carries an arch which forms one square order, and the angles of the jambs support another square order on each side of the first. The architecture, though simple, is good, and, together with the chancel arch, indicates a rather advanced date in the Norman period, probably towards the end of the twelfth century. Within the chancel arch there stands a very interesting relic of Norman design, probably of older date than the church. This is the stone font, the upper part of which consists of a semi-hemispherical stone basin, with

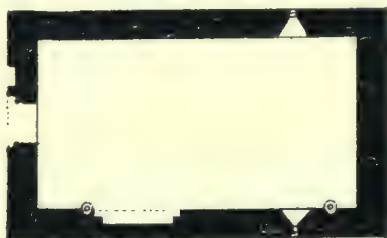
FIG. 188.--St. Oran's Chapel. Plan.

As stated in the Introduction,\* this chapel is supposed by Dr. Reeves to have been built by Queen Margaret about 1074. The chapel (Fig. 188) is a plain oblong, 30 feet long by 16 feet wide internally. As often happens in West Highland chapels, there is no window in the east wall.

The only light was obtained from two narrow windows near the east end, one in the north and the other in the south wall, immediately opposite one another.

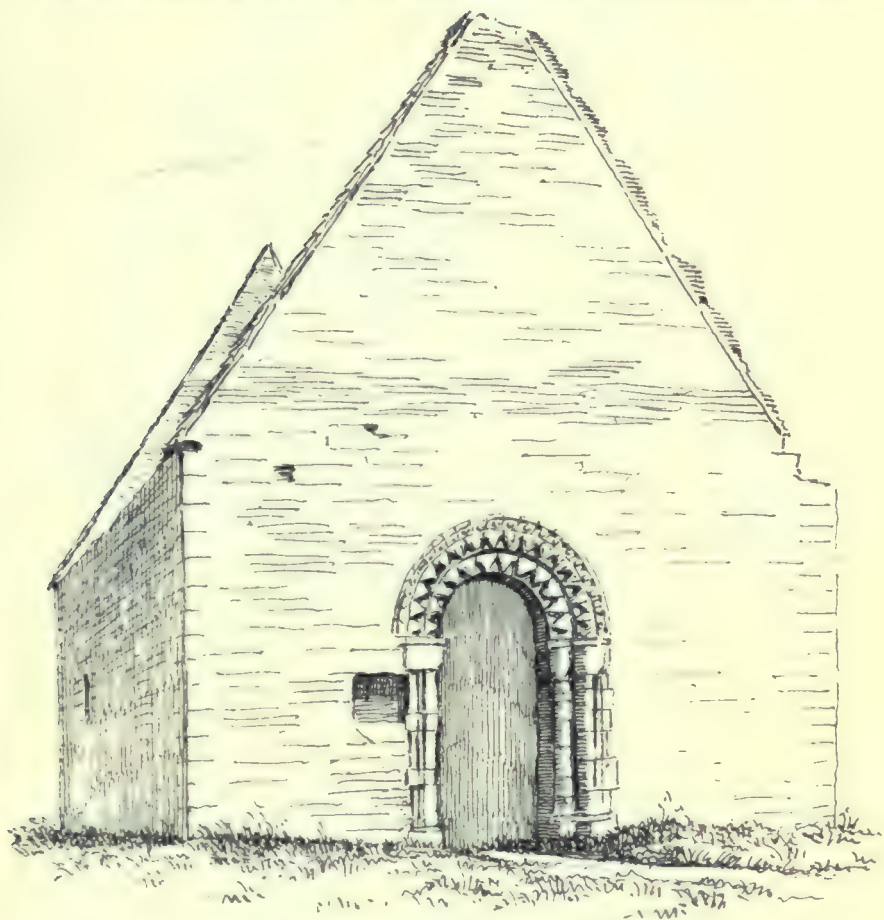
FIG. 189.—St. Oran's Chapel. View from West.

The entrance doorway (Fig. 189) is in the west wall. It is more elaborate than most of the West Highland chapels, having (Fig. 190) two nook shafts on each side with plain cushion caps, surmounted by a semi-circular arch in two orders with a label, all of which have been elaborately carved with Norman enrichments. Those of the label consist of a series of round and rather pointed knobs. The outer order seems to have been carved with a bird's head ornament, and the inner order with a kind of chevron. All the carved work, however, is greatly decayed by exposure to the weather. The building has a gable at each end, and has had a wooden

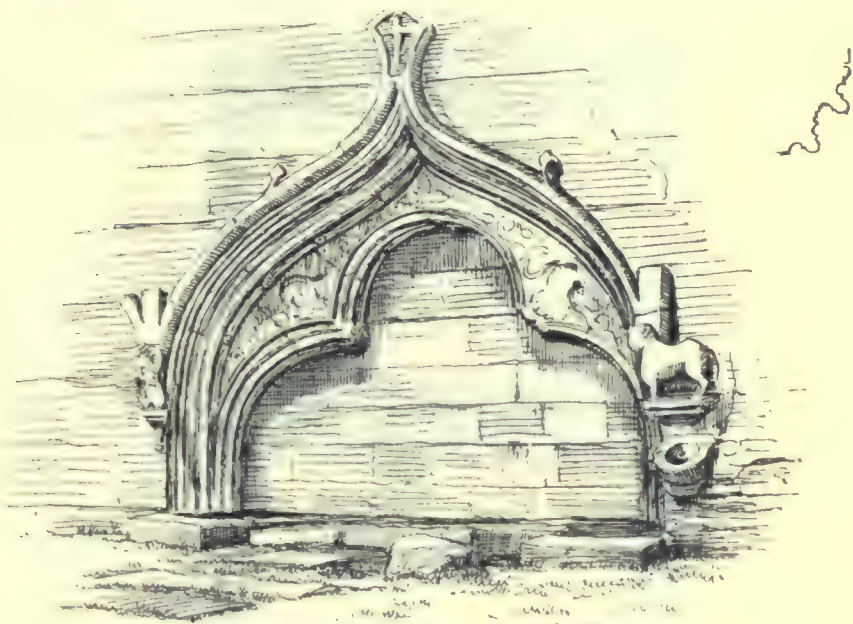
FIG. 191. - St. Oran's Chapel. Monument.

roof. In the interior of the south wall a somewhat elaborate monument (Fig. 191) has been inserted, which, from its style, is evidently of late date. The canopy consists of two orders, one of an ogee form, with weather table, which has been ornamented with crockets, and has a crucifixion introduced in the pinnacle at the top of the arch. The label terminations at each side

consist of animals like lions of an exaggerated size. The inner arch has a large cusp which has been filled with Celtic carved scroll work, but it is now much decayed. A broken piscina stands at the west side of the monument. A number of very interesting and finely carved Celtic monumental slabs are preserved in the chapel, and a great many more, some of

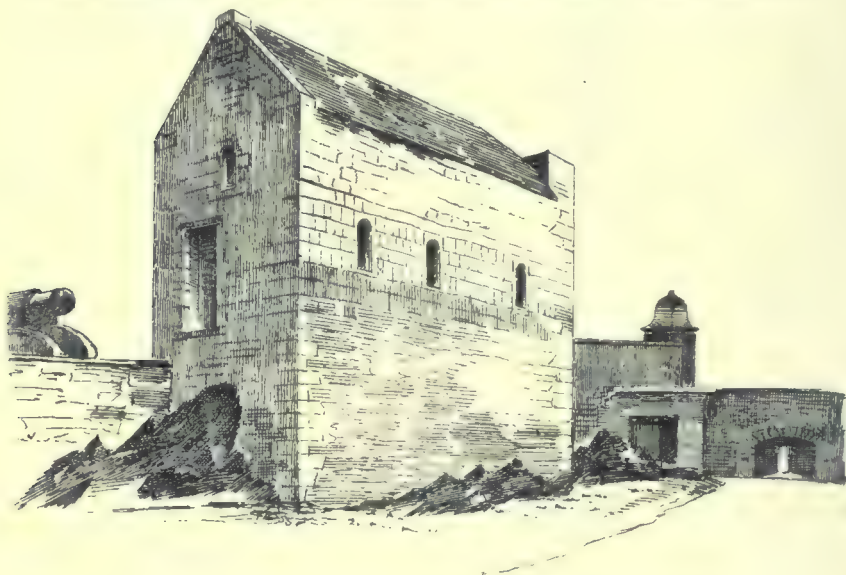
FIG. 194.—St. Margaret's Chapel, Edinburgh Castle. View from South-West.

The genuine surviving Norman masonry begins below the line of the south windows (see Fig. 194). The first two or three courses, which extend up to the sills of the south windows, are built of reddish stone, above which are five courses of a bluish grey stone, the upper course being above the windows. All the masonry above that level on the south and north sides is later work.

The masonry of the north and east sides has been greatly interfered with, as has also that of the west end, where, however, there are several consecutive Norman courses. The east wall appears to have been carried to a greater height than the other walls (Fig. 194), as if some higher building had been attached to the chapel.

square-headed doorway, with splayed opening, has, possibly in the sixteenth or seventeenth centuries, been cut through the west wall (see Fig. 194). There are indications of a narrow doorway having formerly opened into the chancel on the north side. It is now built up, and forms an ambry on the inside. (See Fig. 192.)

chancel. There is also a window in each of the end walls, the one in the west end being at a considerably higher level than the other (see Fig. 194). All the windows are splayed widely on the inside, and slightly so on the outside, and they are round arched. They are all about 8 inches wide by about 2 feet high. The two westmost windows in the south

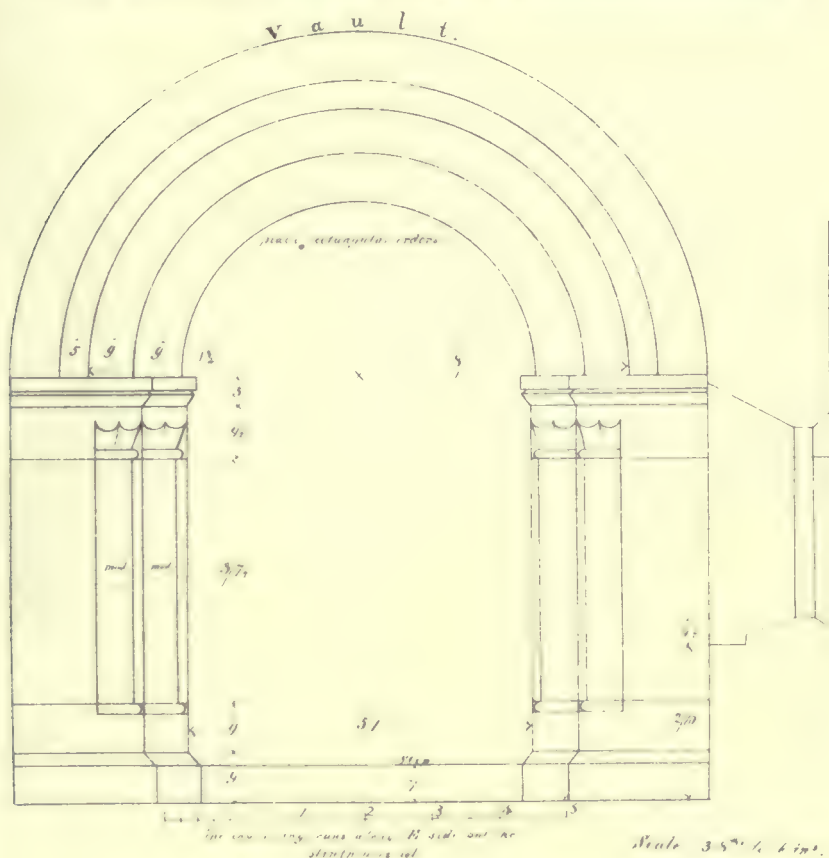
FIG. 195.—St. Margaret's Chapel, Edinburgh Castle. Elevation of Chancel Arch.

The chancel arch (Fig. 195), while quite in proportion to the chapel, is little larger than an ordinary doorway. Its opening measures 5 feet 1 inch wide by 6 feet 4 inches to the springing of the arch, and 9 feet in height, measuring from the nave floor to the soffit of the arch, and there is a step up to the chancel. Each jamb (Fig. 196) has two monolithic shafts, set in nooks, with cushion cups. The arch, which is in two corresponding orders, is decorated with the ordinary chevron design. (Fig. 197.) Enclosing the arch is a label moulding, enriched with a lozenge pattern. The arch on the chancel side is quite plain.

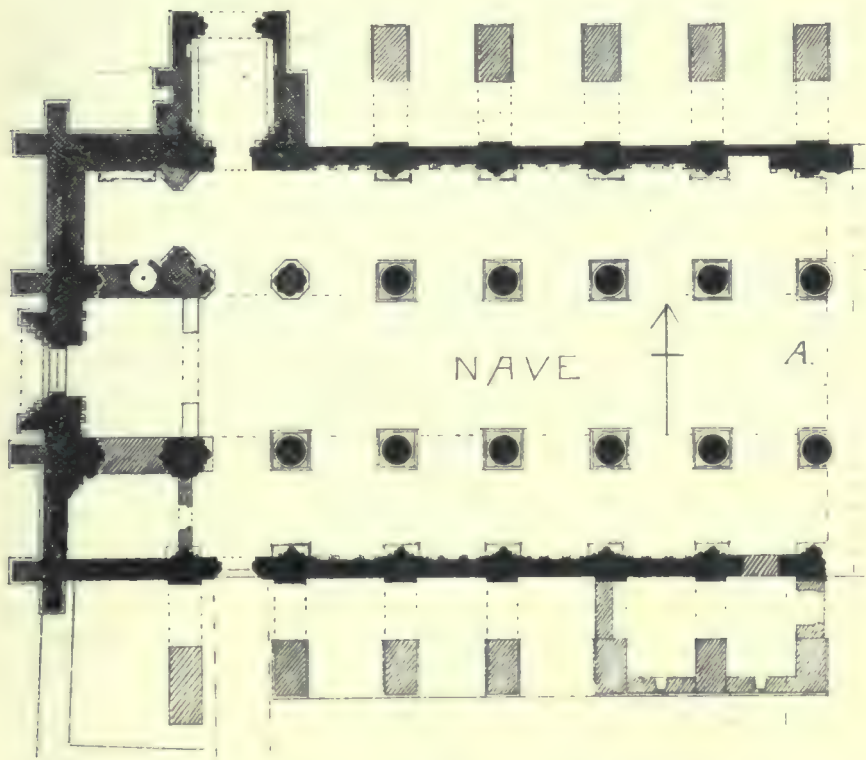
FIG. 199.—Dunfermline Abbey. Plan of Nave.

The nave (Fig. 199), which is wonderfully well preserved, measures about 106 feet long inside, by about 55 feet wide between the aisle walls. The piers are circular, and measure 4 feet 4½ inches in diameter. The plan of these, with that of the wall responds (Fig. 200), indicates that the original intention (which was carried out) was to groin the aisles. The two eastern bays between the eastern pillars are built up with solid masonry, and only a portion of the arches is seen. The original respond at the east gable wall, against which these arches rested, has long since disappeared, in connection with the erec-

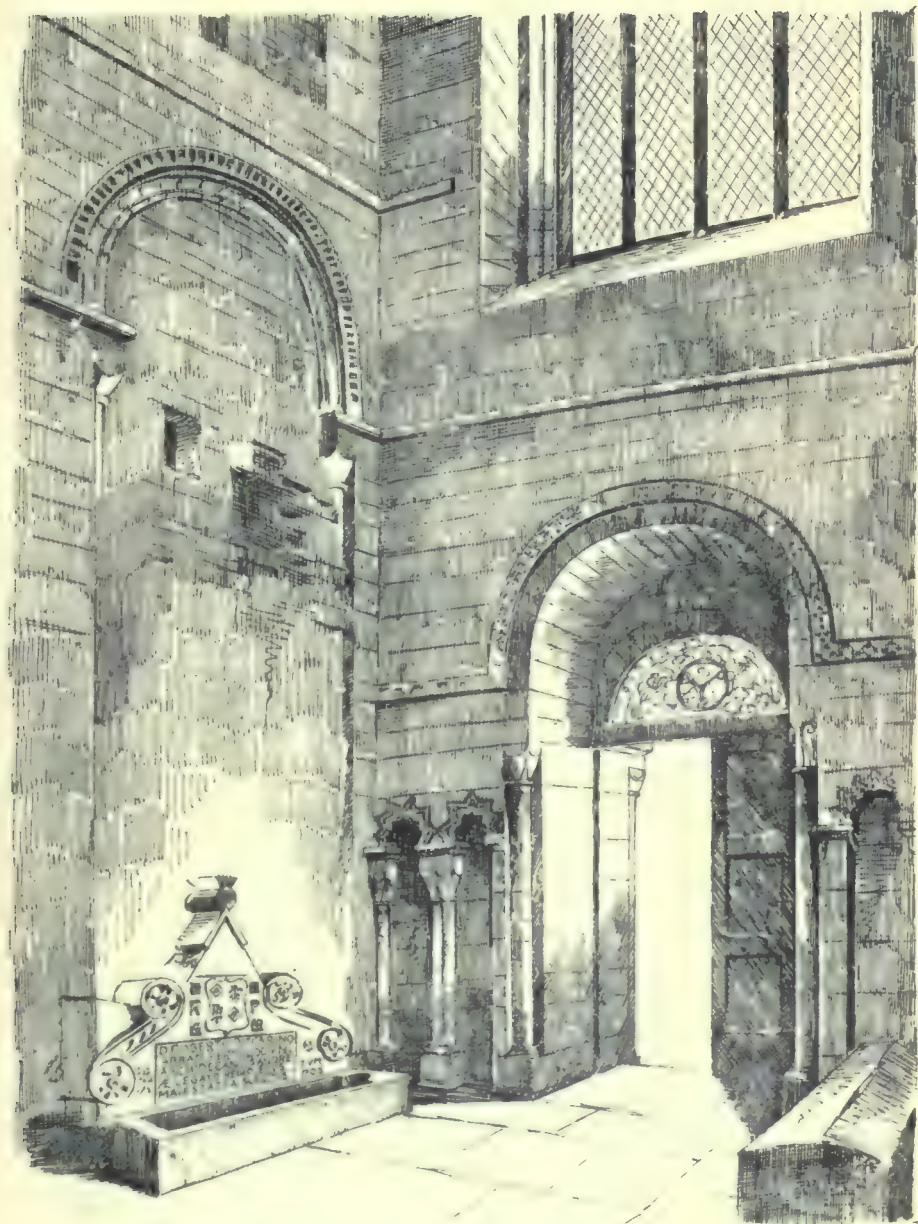
FIG. 201.—Dunfermline Abbey. Interior of West End of Nave.

The two western bays, and the triforium arches above them (one on each side), have also been filled up with solid building in order to strengthen the western towers. The southern of these arches is shown in Fig. 201. The pillars which support the west towers are of greater size than the others, and are of a different section. One of the pillars and the corresponding arch of the north arcade are of late Gothic work, and may be part of the repairs ordered by the Privy Council in 1563, || or of the work done in 1594, under the direction of William Schaw, Master of Works, who at that time built the north-west tower and steeple

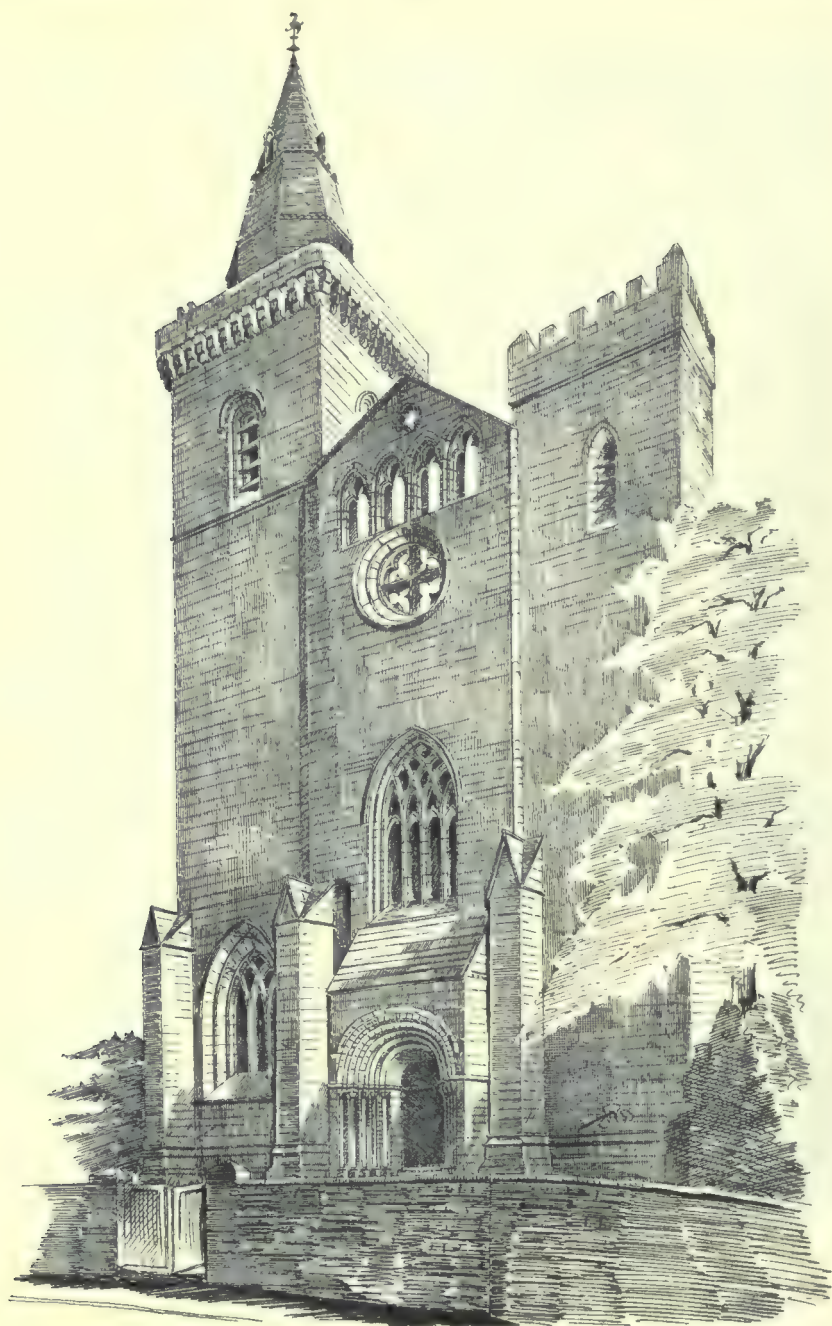
FIG. 202.—Dunfermline Abbey. West End.

(Fig. 202), as well as the porch on the north side of the nave (Fig. 203). At the same time, also, certain great buttresses (Fig. 204) were built against the outer walls, which are now conspicuous features of the structure.

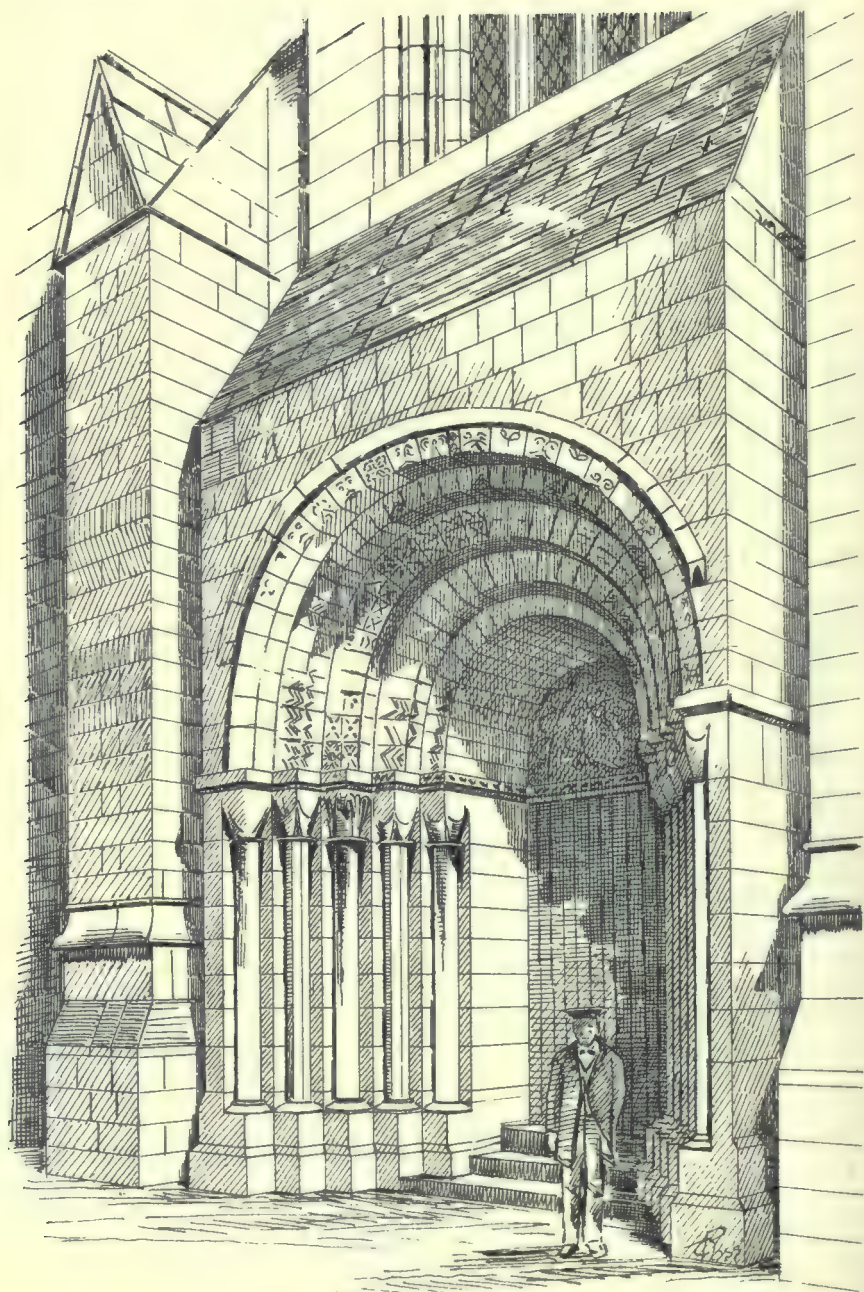
FIG. 205.—Dunfermline Abbey. Western Doorway.

The great western doorway of the church (Fig. 205) remains unaltered, and is a good example of Norman work. It consists of five orders, having round and octagonal shafts alternately, chiefly with cushion caps, but some are ornamented with scrolls (Fig. 206). The abacus is heavy, and is carved with sunk diapers. The orders are continued round the arches, and contain chevron ornaments (much decayed), rosettes, and diapers. The outer order contains large heads and geometric figures in the alternate voussoirs, an arrangement similar to that at Dalmeny and Whithorn, where also the geometric figures resemble those adopted here. The original north doorway (Fig. 207), which is partly concealed by Schaw's porch, is similar in design, with the addition of an arcade above the arch (see Fig. 203), somewhat resembling, but plainer than that over the doorway of Dalmeny Church, on the south side of the Forth. The south doorway of the church on the opposite side from the porch is a late work. There appears to have been another south doorway at the east end of the nave, but it is now built up. The whole of the aisle walls are arcaded in the interior (Fig. 208) up to the height of the window sills, but the arcade has been partly cut away for monuments.

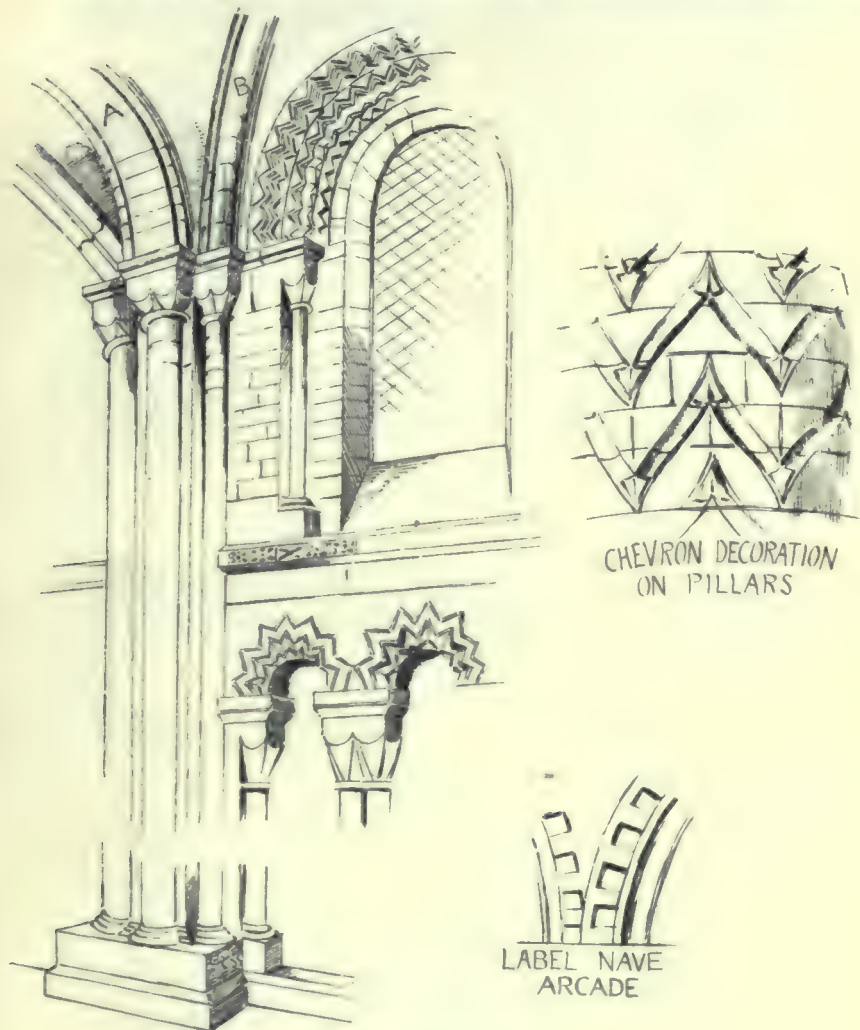
FIG. 208.—Dunfermline Abbey. Aisle.

Fig. 208 shows the wall shafting and springing of the ribs in the aisles, and the mouldings of the nave arcade, with the arcading beneath the

windows. It also shows the original aisle windows on the inside, while Fig. 213 shows their appearance on the exterior. It will be observed in the latter that there is the same sunk or label ornament on the drip-stone as there is over the arches of the main arcade. Above the aisle window (see the same Fig.) are the lights of the triforium gallery. These have triangular heads, formed by two stones. They appear to have been rounded or moulded on the edge, and spring from sunk shafts having carved capitals. They are now very much decayed, and have all been restored except two on the north side.

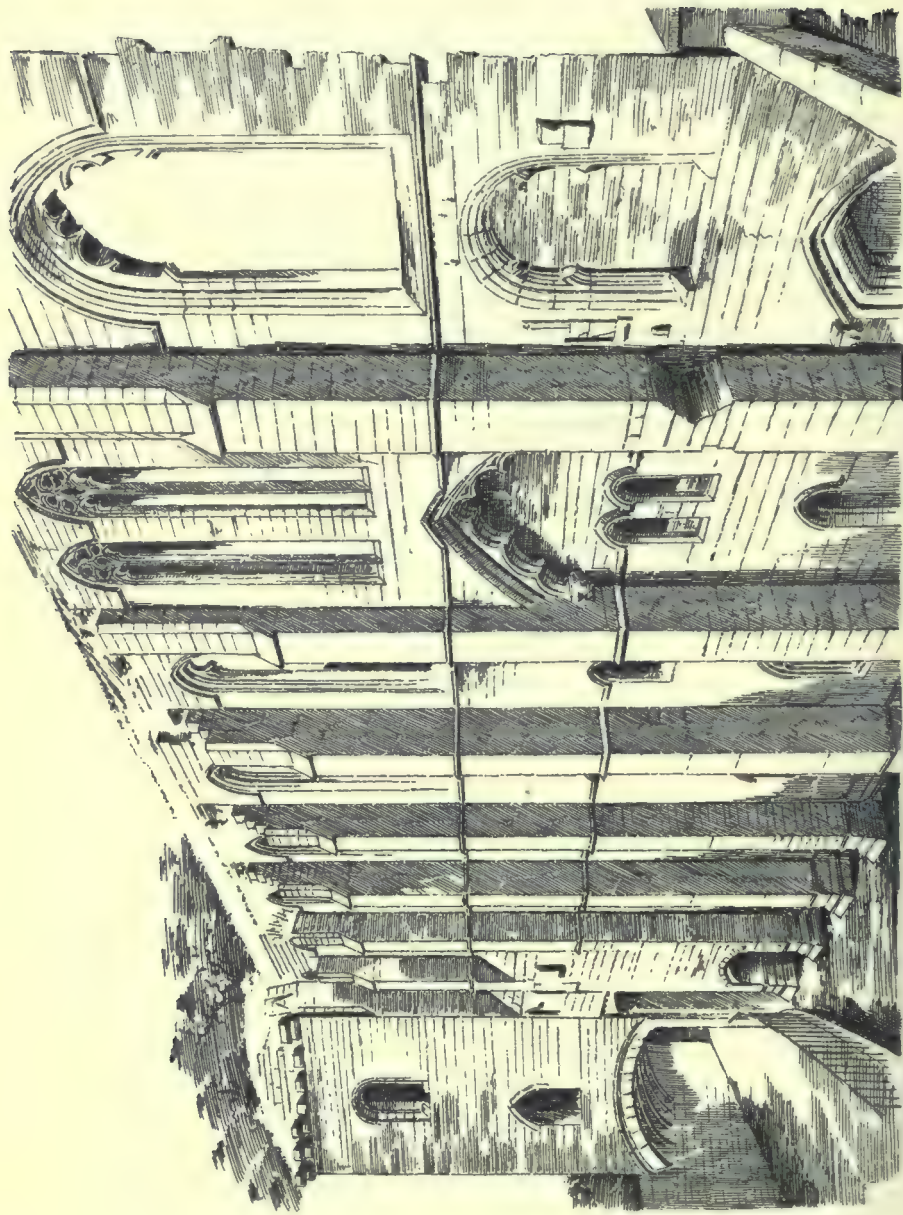
FIG. 215.—Dunfermline Abbey. South Wall of Refectory.

length and height of its south and west walls still exist. There is also a small portion of the return of its north wall, adjoining the west gable wall. Indications of its east wall also exist, thus enabling its dimensions to be fixed at 103 feet in length by 34 feet in width. The south wall (Fig. 215) was divided into seven bays, and in six of these there are lofty two-light windows (Fig. 216). The eastern bay is occupied by the pulpit or reading-place, from which one of the brethren read aloud during meals. This place, which occupies the whole of one bay, is about 15 feet long, and is corbelled outwards on a cusped arch (see Fig. 215) about 4 feet 6 inches wide. It is lighted from the outside by two windows, which have mullions and tracery, still entire, flush with the face of the wall. On the side next the hall there are two lofty openings.

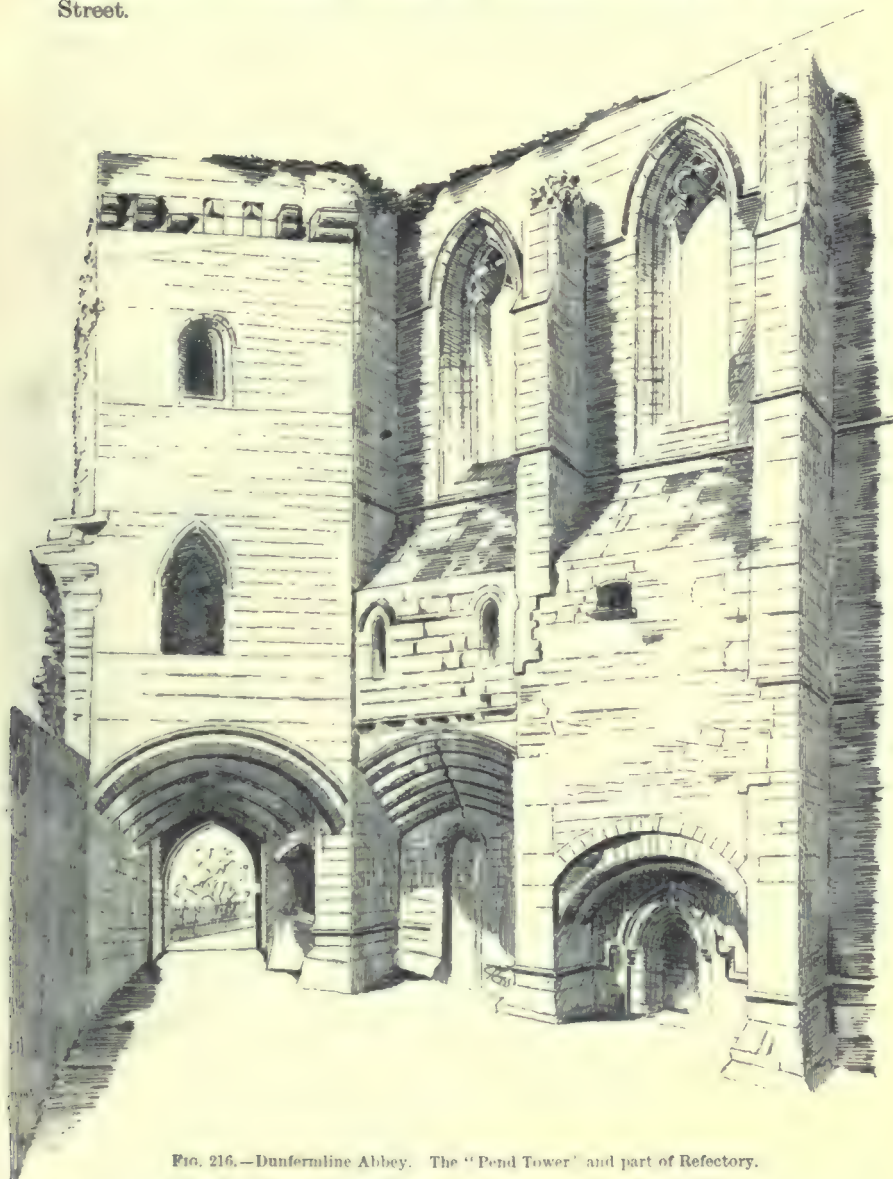
FIG. 216.—Dunfermline Abbey. The "Pend Tower" and part of Refectory.

or archway, whence the building is called the "Pend Tower." The outside of the refectory and "Pend Tower" (see Fig. 216) is very

The above passage and staircase are additions made, without doubt, at the time when the tower was built. This is clearly seen in Fig. 216.

From this drawing it is obvious that the arches were thrown between the already existing buttresses of the refectory, and in the second bay the arch is at a low level to permit of the descending stair already referred to. The builders have just managed to save a very beautiful door-

angles to the first arch from the end of the passage to meet the cross vault. This probably indicates that steps lead down in the passage to the level of the rooms below the refectory. But the place cannot be properly seen, being choked full with the grass and rubbish thrown in from the churchyard. This passage is a very effective feature, as seen from the outside. It is supported on arches thrown from buttress to buttress, and is covered with a stone roof above (see Fig. 216).

As already mentioned, the monastery was burned by Edward I. in 1303-4; but, according to Tytler,\* the church escaped. Froissart, however, narrates that in 1385 Richard II. burned the abbey and town. It is impossible to say to what extent these devastations were carried, but we doubt if any of the existing monastic buildings belong to an earlier date than that last mentioned. Perhaps the south wall may be older, and has been restored. The tracery of the refectory west window belongs to the end of the fifteenth century. The "Pend Tower" was built after the refectory was finished, as it abuts against the westmost buttress (as seen in Fig. 216) in a way

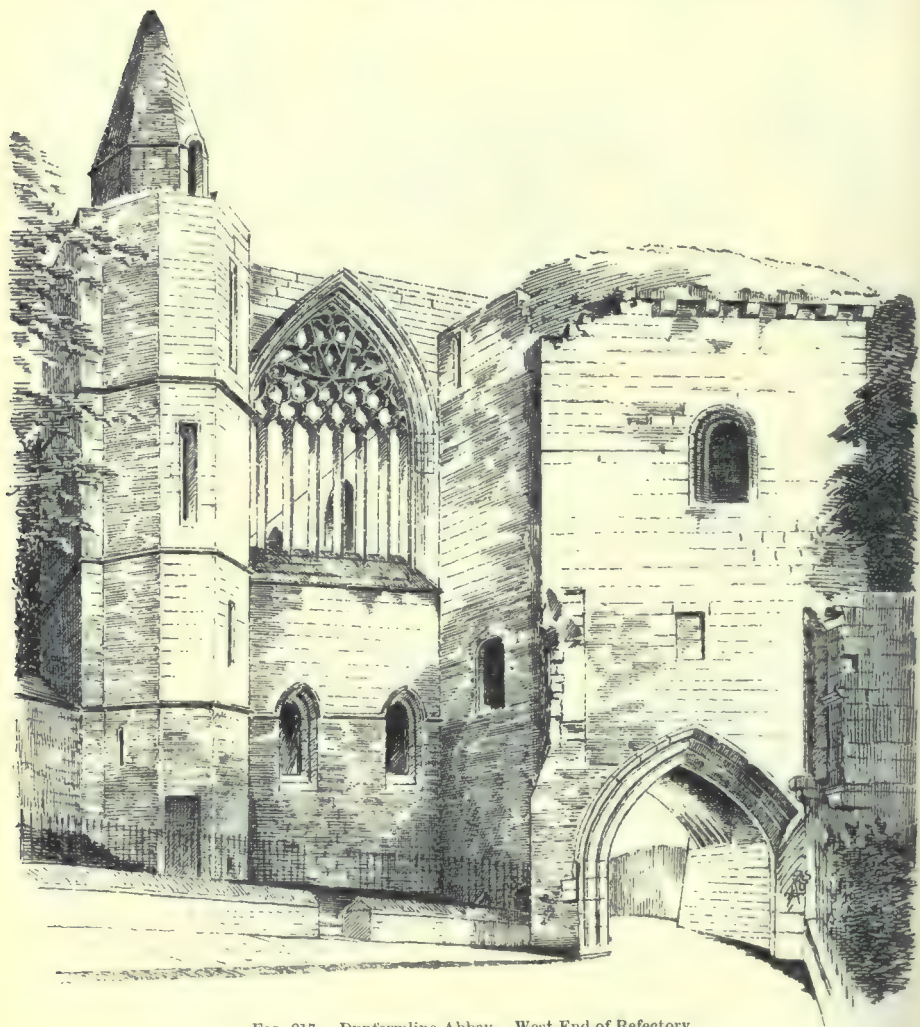
FIG. 217.—Dunfermline Abbey. West End of Refectory.

imposing, with the simple row of lofty buttresses and windows along the top. The west gable wall of the refectory (Fig. 217) is still entire, and has a large window of seven lights. The tracery of this

window is in good preservation (Fig. 218), and is one of the most favourable examples of a kind of tracery developed in Scotland during the fifteenth century. At the north-west corner of the refectory is the staircase tower (see Fig. 217), which leads down to the offices below, and upwards to the refectory roof, over which access was obtained to the upper

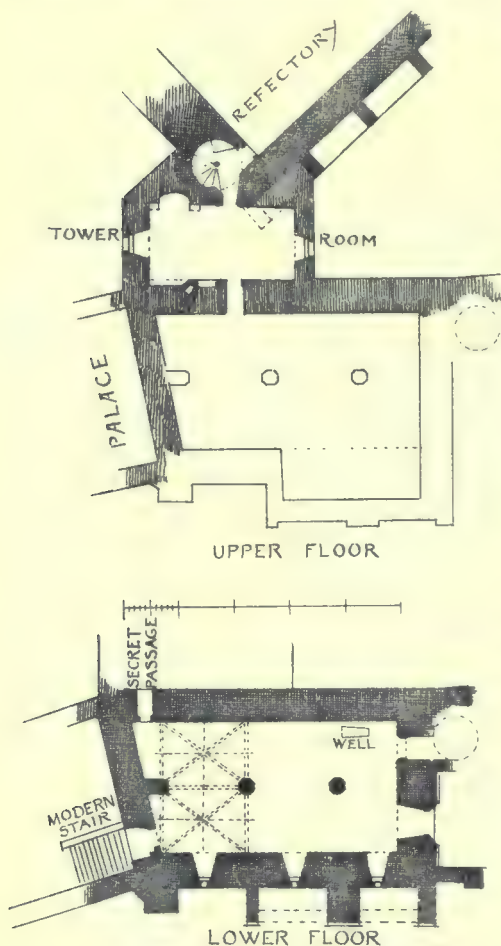
FIG. 219.—Dunfermline Abbey. Plan of "Pend Tower," &c.

story of the "Pend Tower." In the north wall of the refectory, near the west end, are the remains of a flue, which may have belonged to a fireplace. The "Pend Tower" is still entire, wanting only the cape house and roof. It served as a connecting passage between the abbey buildings and the royal palace beyond. A door led from the refectory (see Plan, Fig. 219) by a passage into a groined chamber, and from thence into a room

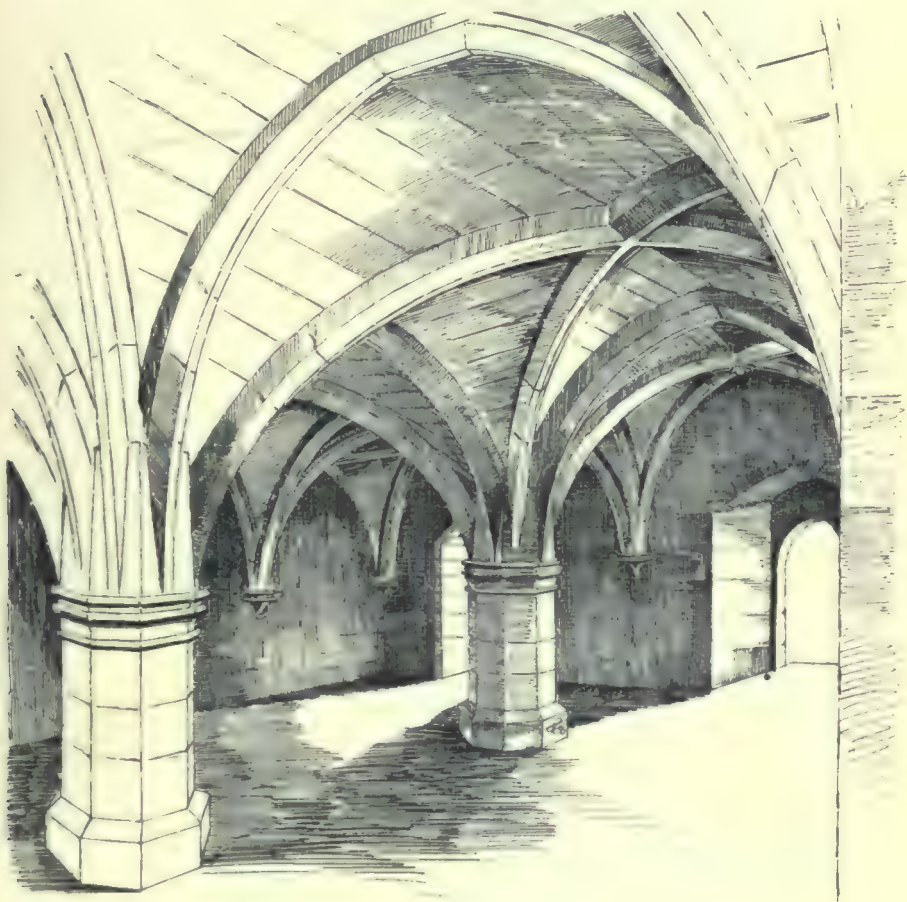
FIG. 220.—Dunfermline Abbey. Room below Kitchen.

in the palace situated over the kitchen. The kitchen is a lofty room, now roofless, having remains of large fireplaces and some curious recesses. Below the kitchen, but entering from another part of the palace, there is a large vaulted apartment with central pillars. (Fig. 220.) These pillars were continued up through the kitchen, and probably to the room, now gone, which stood over the kitchen. Another arched passage led from this apartment through below St. Catherine's Wynd and up to the monastery. The building known as the palace was, doubtless, intimately connected with the monastery, and the kitchen shown on the plan may have been used in connection with both.

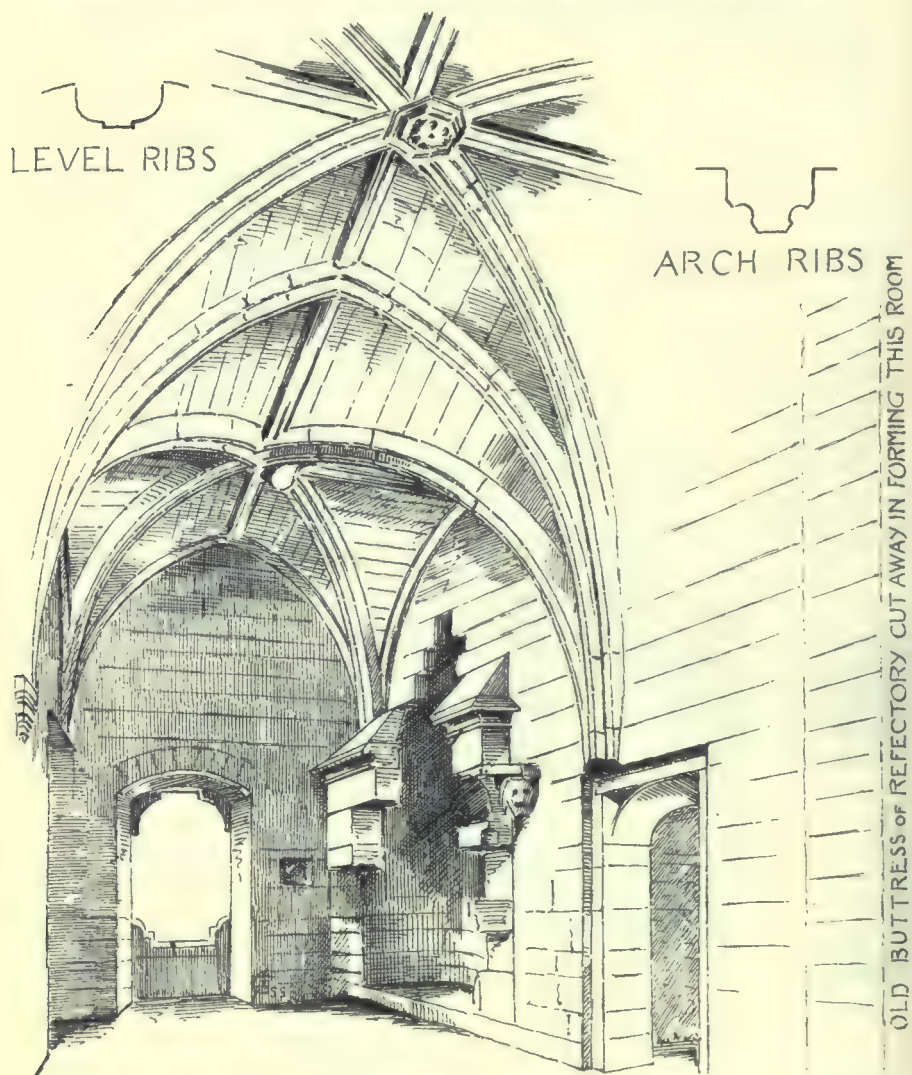
FIG. 221.—Dunfermline Abbey.

it would not have done had the whole been of one construction; also, the corner buttress has been cut away, as may be seen at the right-hand side of Fig. 221.

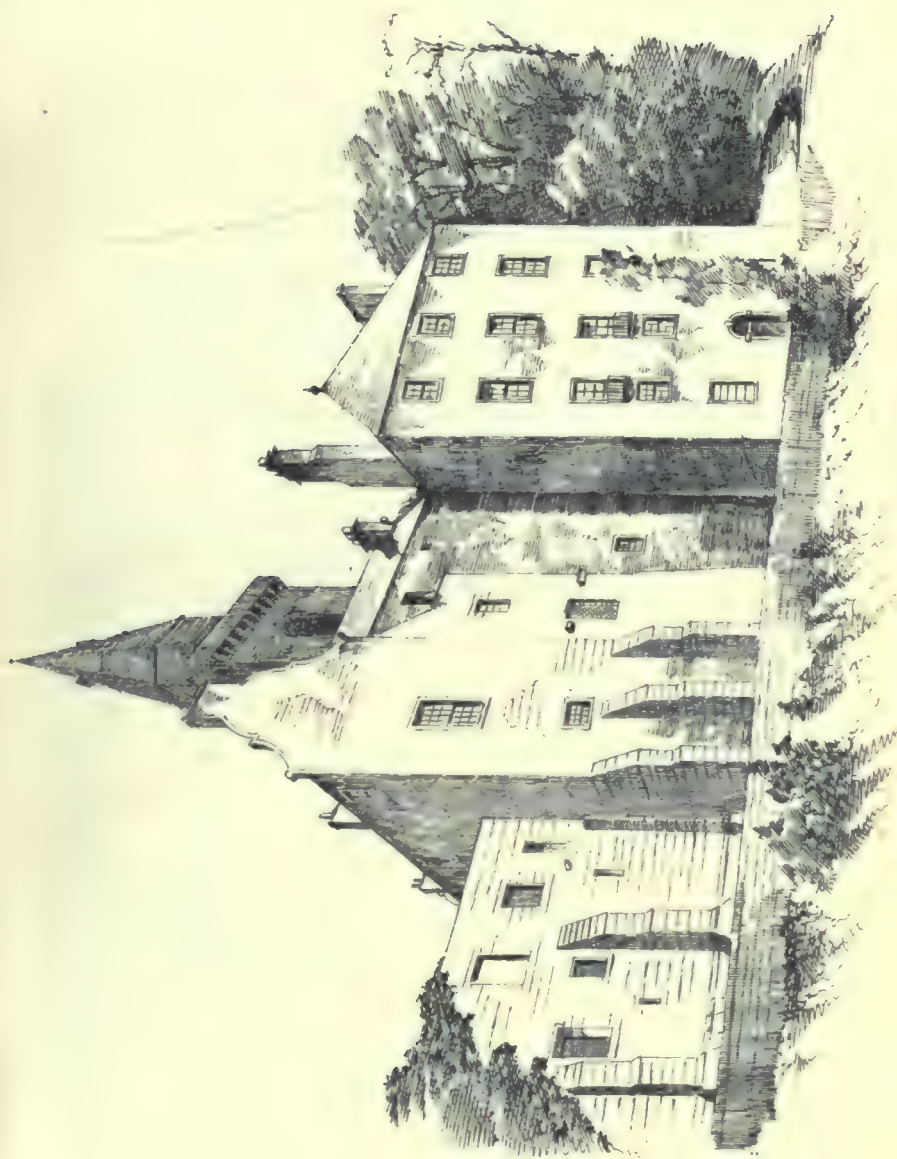
FIG. 222.—Dunfermline Abbey. Old Buildings to North-West of Church.

there are considerable remains of buildings still existing (as shown on Plan) to the north-west of the abbey, and there seems every probability that they formed part of the structures of the abbey and of the Queen's House. They are extremely picturesque as seen from the low ground to the west. (Fig. 222.) The lofty house on the right hand dates probably

from the end of the seventeenth century, and is a fine example of its period. The adjoining buildings are considerably earlier, and in the lower parts, where they are buttressed, they are probably of pre-Reformation times. The upper portions are somewhat later, and are very likely part of the work of Schaw. The porch to the latter buildings is on the other

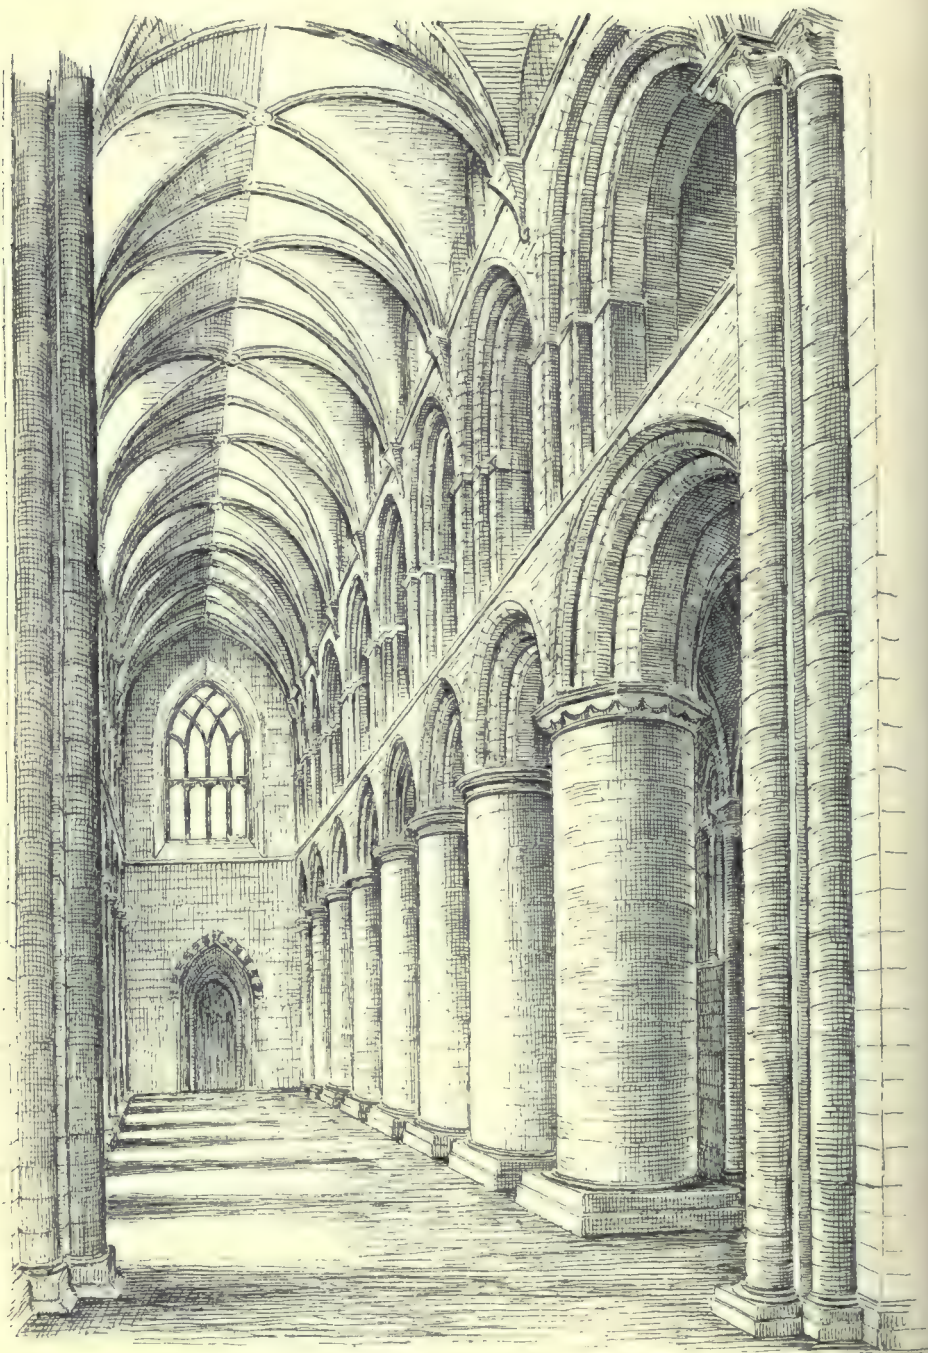
FIG. 224.—Kirkwall Cathedral. The Nave, looking West.

The first view of the interior is striking and impressive. (Fig. 224.) The long perspective of the great round pillars and arches on each side of the nave, surmounted by the round arched triforium and clerestory, and the lofty roof covered with simple vaulting, give an impression of size and height which is larger than is borne out by after measurement. This appearance of great size has often been remarked of St. Magnus', and, no doubt, arises from the height and length of the edifice as compared with its width, which between the piers is only 17 feet, while the length of the nave is 111 feet, and the height to the apex of the vault is about 50 feet. The cathedral is found to be complete in all its great divisions. (Fig. 225, Plan.)\* The nave has side aisles, which are vaulted, and the side walls are arcaded with interlacing Norman arches. The choir is, unfortunately, excluded by a glass screen from the general view of the cathedral, owing to the east end being still used as the parish church. The choir is of considerable length, being 85 feet 6 inches long by 47 feet 6 inches wide, and has main piers, triforium, and clerestory, of about the same height as the nave. It is also vaulted, and has vaulted side aisles. The longitudinal section (Fig. 226) shows the comparative heights of the nave and choir.

It seems likely that soon after the completion of the above portions attention was given to the continuation of the nave westwards for several bays. The piers have the same round form as the original ones, but the caps are no longer octagonal, but round (see Figs. 224 and 233), and instead of the cushion form, the caps are moulded. The north

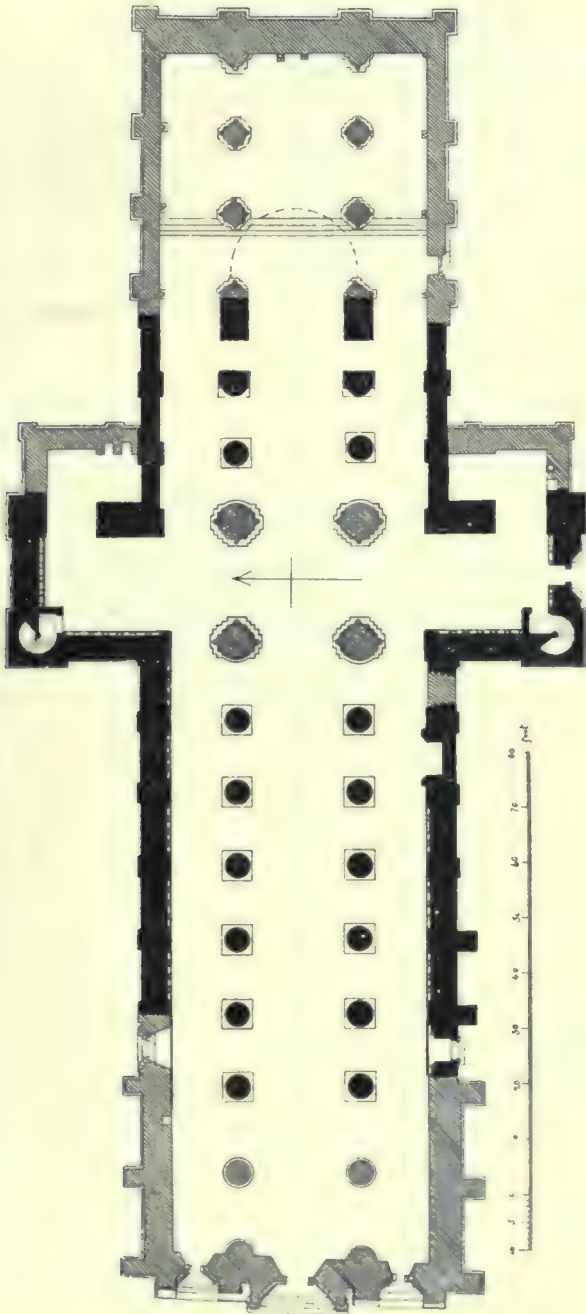
FIG. 225.—Kirkwall Cathedral. Ground Plan.

The first parts of the cathedral built (shown by black tint on Plan) were the three westmost or Norman bays of the choir, with their aisles, both the transepts, the crossing (afterwards altered), intended to receive a tower over it, and two bays of the nave, which served to form an abutment for the crossing. These portions are all (where unaltered) in the earliest style of Norman work in the edifice. The round piers and responds of the choir, the two south piers and one north pier of the nave (with their cushion caps) (Fig. 233), the main arches (with their label mouldings in the choir and transept) (see Figs. 227 and 234), the round arched and labelled windows in choir, transept, and nave (see Fig. 228), and the interlaced arcades in the latter (Fig. 235), all point to a somewhat advanced period of Norman work.

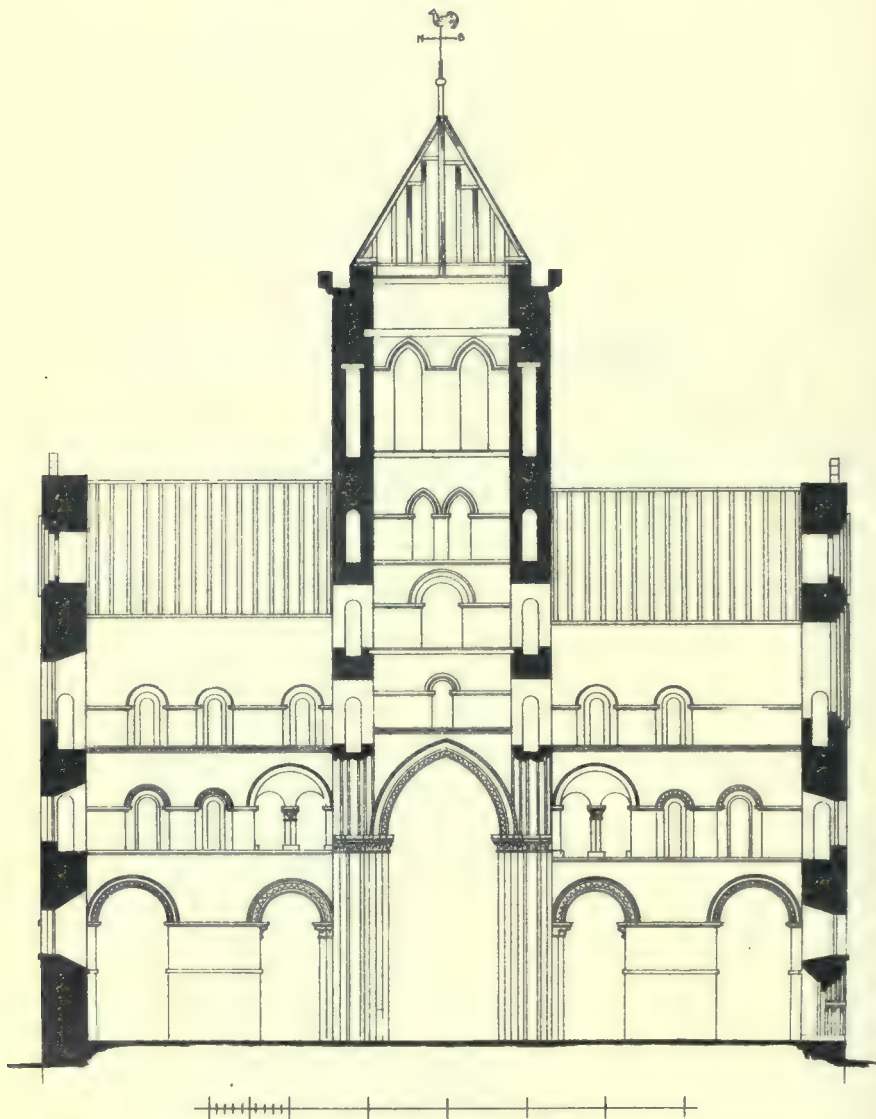
FIG. 227.—Kirkwall Cathedral. Section through Transept from North to South.

The transept is 90 feet long by 17 feet wide, and has a great appearance of height, but is not vaulted. It has no aisles, but has a vaulted chapel projected to the east from each division of the transept. Fig. 227 is a section through the transept from north to south.
